FINAL REPORT OF SPECIFIC PURPOSE LIDAR SURVEY

LiDAR, Breaklines and Contours for Dixie County, Florida

State of Florida
Division of Emergency Management
Contract 07-HS-34-14-00-22-469
Task Order 20070525-492718a
PDS Task Order B

October 30, 2009

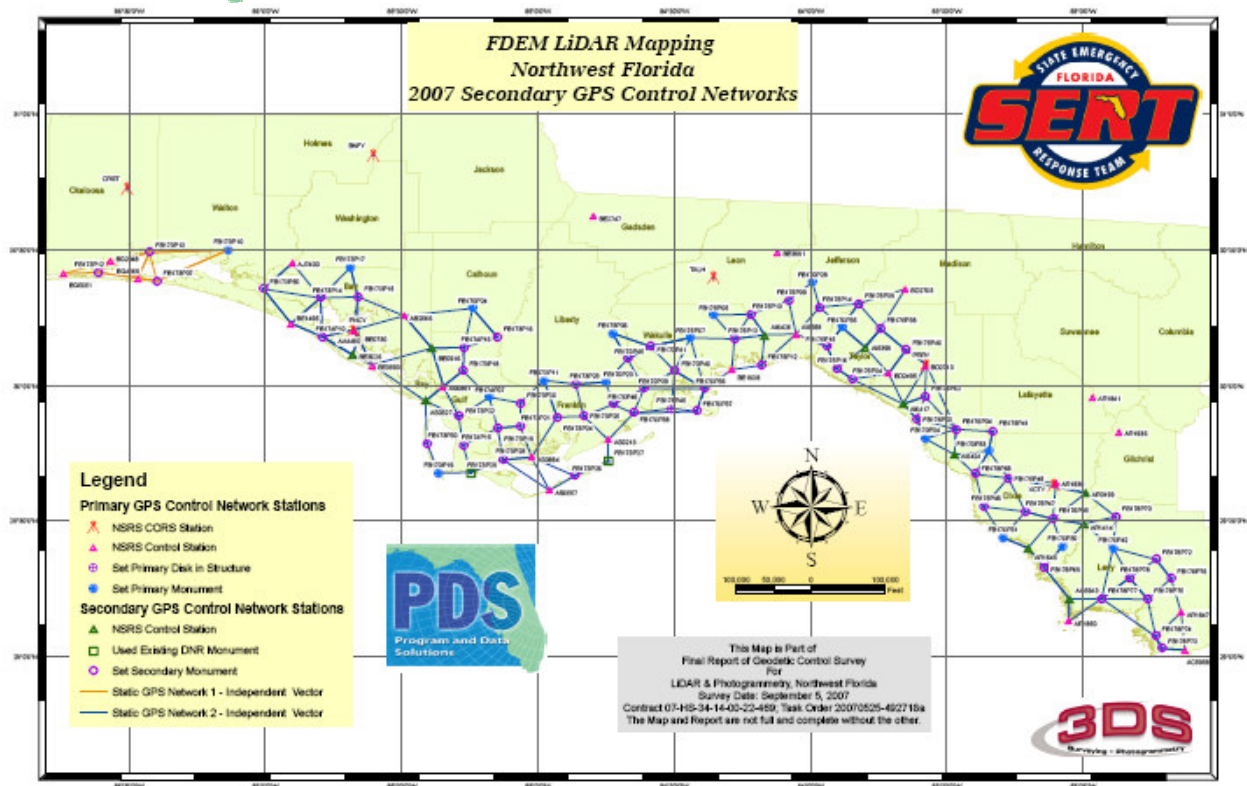
Figure 2. Secondary Control Networks

The Secondary network stations (see Figure 2) were used to support the measurement of both LiDAR and orthophoto QA/QC checkpoint sites. They were setup at 15 kilometer spacing per the 2 centimeter requirements for Secondary Control stated in NOS NGS-58.

The first Secondary Control network consisted of 4 stations in the Okaloosa County area. The second Secondary Control network consisted of all remaining mapping areas in the Florida Panhandle. The Secondary Control networks included a total of 80 control points, including 16 recovered NSRS monuments, 2 recovered DNR monuments, and 62 new monuments set for this network. A minimally constrained (free) Least Squares adjustment was run to verify the internal accuracy of the Secondary networks. After evaluating and removing any outliers, a final free adjustment was generated. This final free adjustment consisted of 254 independent vectors. The input error estimates were scaled by a factor of 6.234, which resulted in a properly weighted adjustment with a variance factor of 1.000; there were no flagged residuals. A constrained (fixed) 3-D horizontal adjustment was run using the same input error estimates as were used in the free adjustment; the variance factor was 1.6339 and there were six flagged residuals. A constrained (fixed) 1-D vertical adjustment was run using the same input error estimates as were used in the free adjustment; Station BE3991 was fixed in latitude, longitude and orthometric height; the variance factor was 1.2136 and there were no flagged residuals.

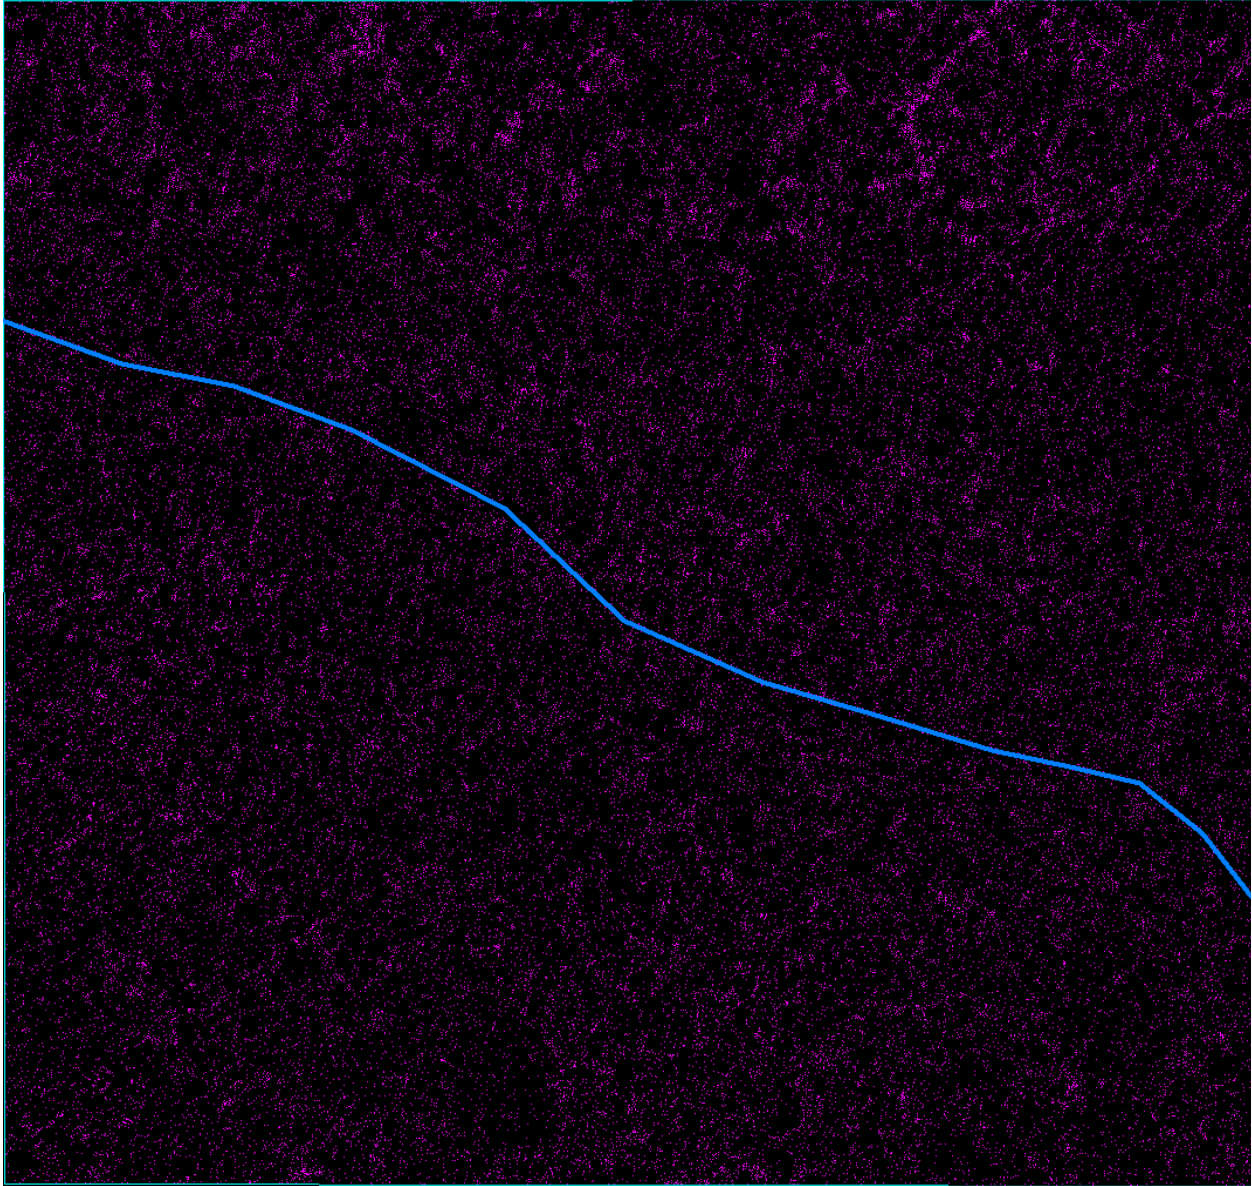
Figure 5. LAS Class 2 (ground) points showing the high density of points that penetrated the vegetation.

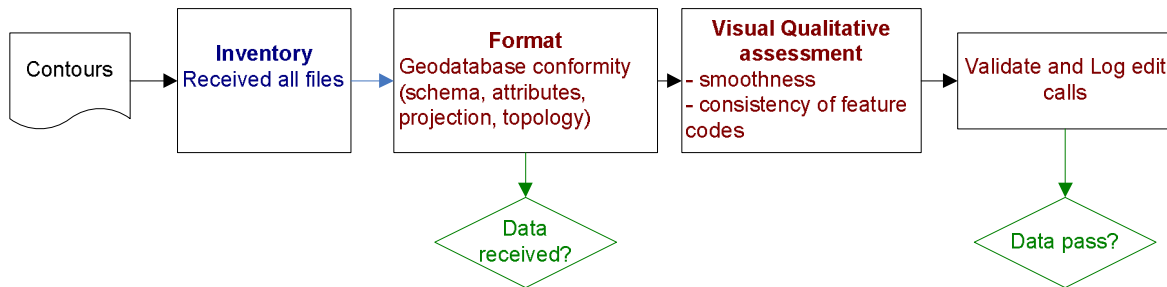
Dewberry also performed the qualitative assessments of the contours using the following workflow.

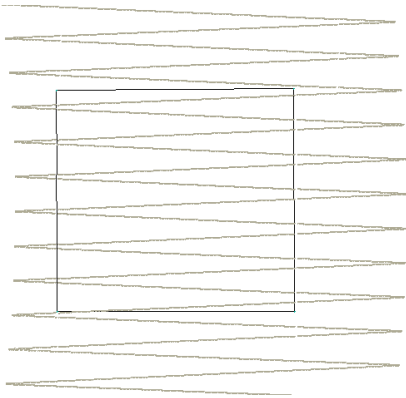
Figure 2: Calibration Pass 1

Additionally, a pass is made in profile mode across the middle of the building to compensate for any bias in pitch.

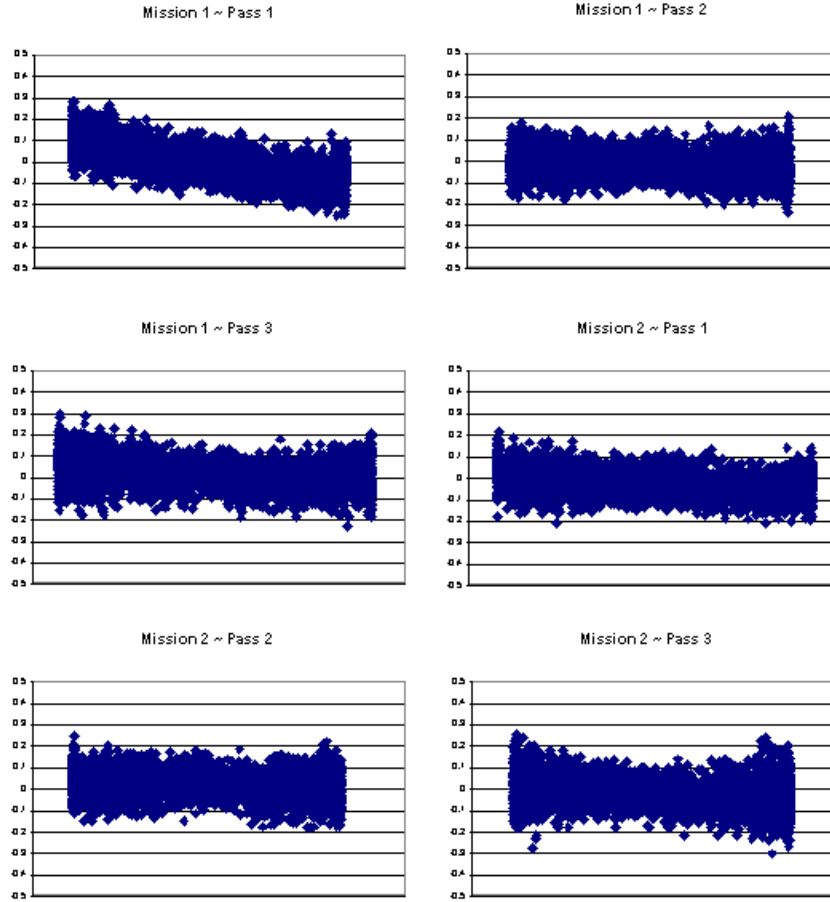
Figure 5: Runway Calibration Results

The calibration is done based on a kinematic survey on the runway. Given that the Kinematic survey RMSE is no better than 4 centimeters as a result of none exact height of the antenna and weight of the aircraft. Sanborn was required to do additional check points in the project area to meet the 9.25 centimeter vertical accuracy requirement knowing that the calibration site is only good to 4 centimeters RMSE. A z bump adjustment was made to the entire data set based on the survey points in the project area and the relative accuracy of the data to itself and in all areas.

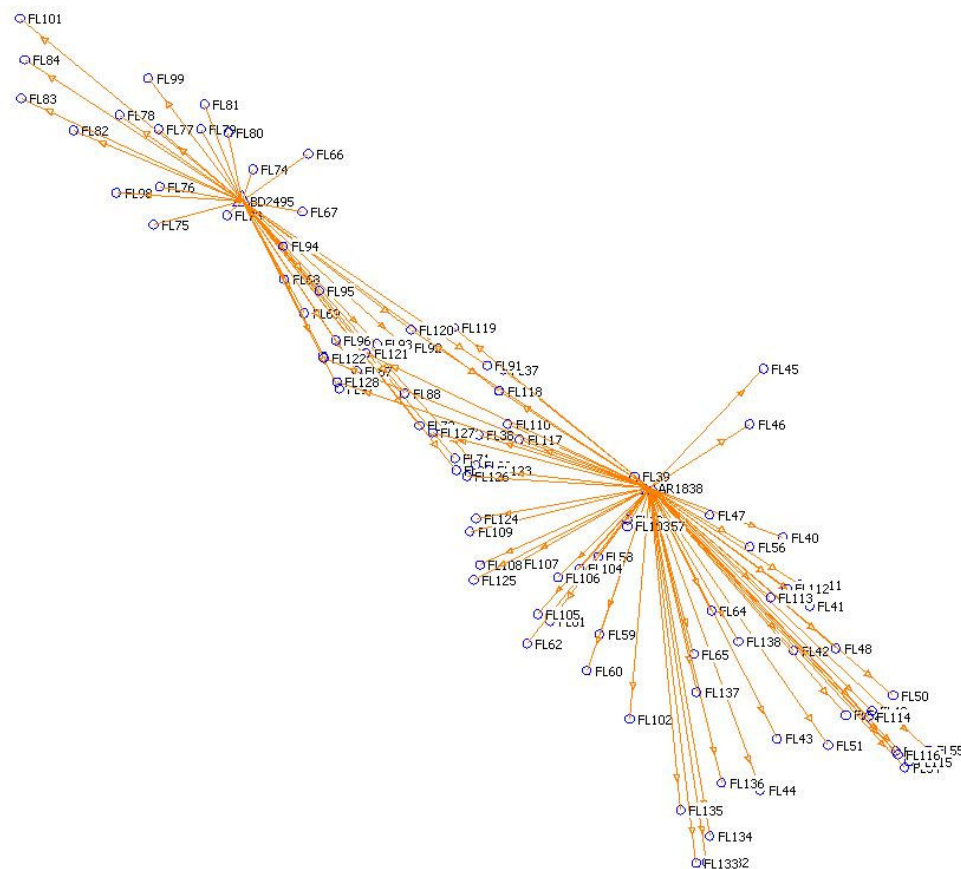
Figure 6: FDEM Survey Checkpoint Diagram

Figure 6 shows a diagram of the checkpoints collected for Dixie County. For the Dixie County area the standard deviation is 0.295 feet and the root mean squared is 0.288 feet. The LiDAR data was compared to each of these classes yielding much better result than was required for the project. Points indicating removed are points outside the statistical variance in the data. Table 9 indicates the results for Dixie County and each point including the overall results as it compares to the LiDAR data set.

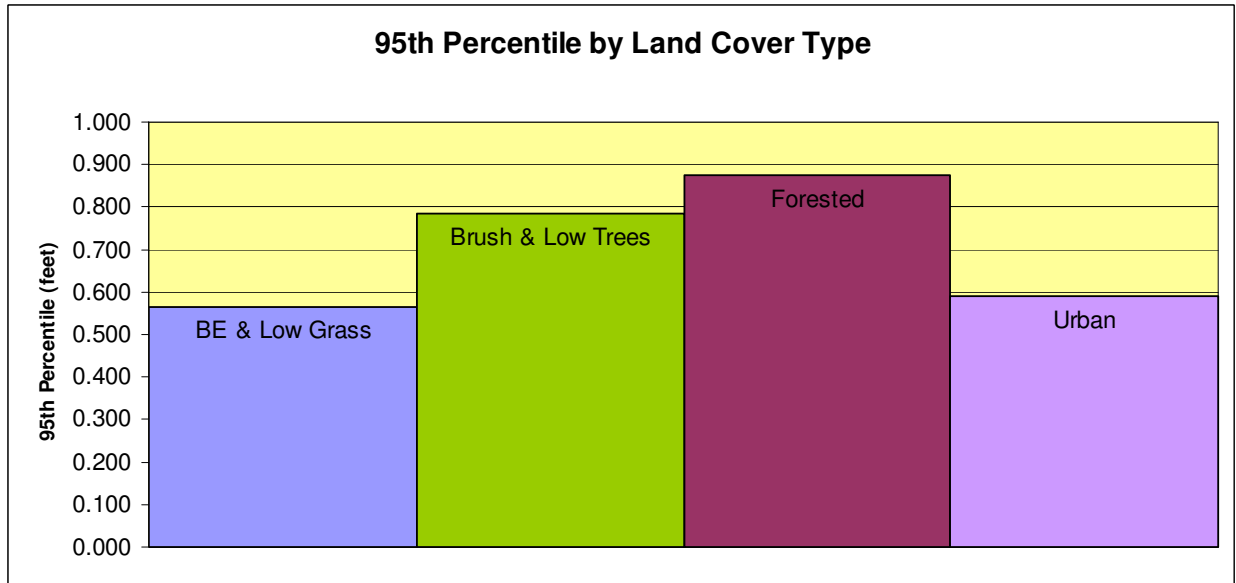
Figure 2 — Graph of SVA Values by Land Cover

Figure 2 illustrates the SVA by specific land cover category.

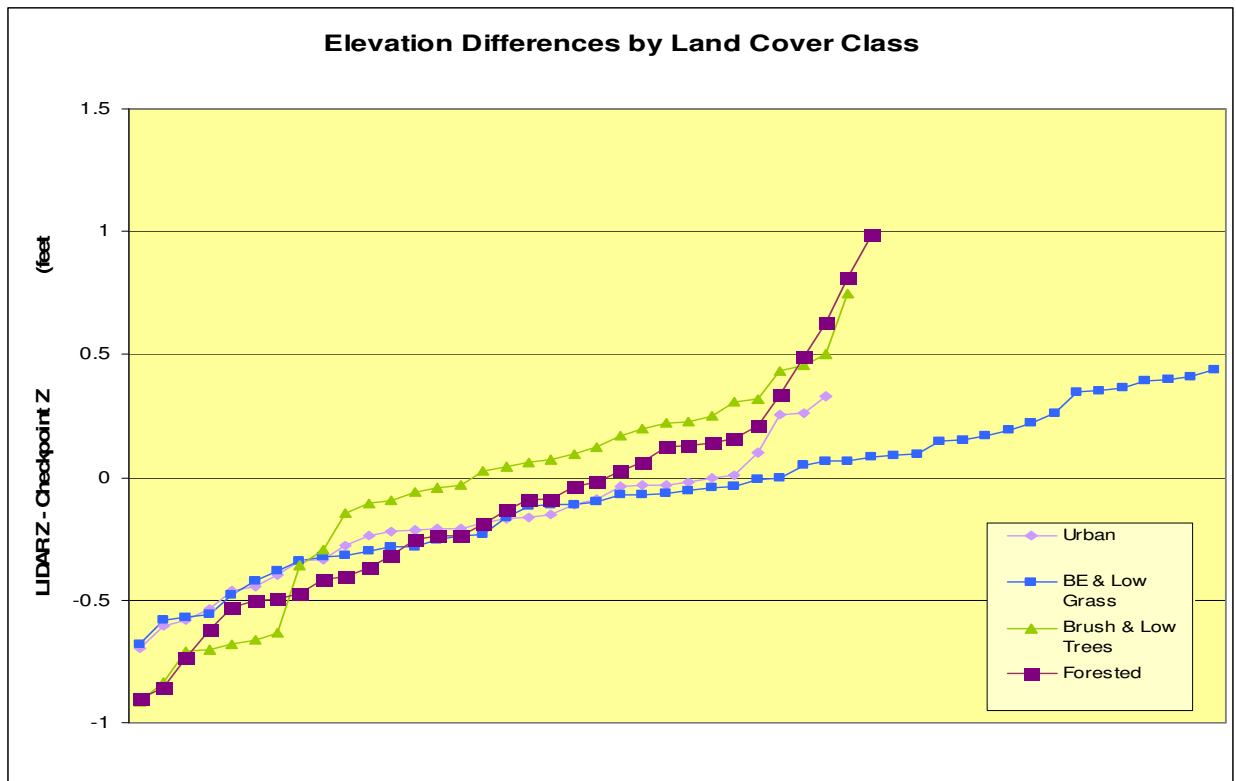
Figure 3 – Magnitude of Elevation Discrepancies, Sorted from Largest Negative to Largest Positive

Figure 3 illustrates the magnitude of the differences between the QA/QC checkpoints and LiDAR data by specific land cover category and sorted from lowest to highest. This shows a normal distribution of points in all categories. Also, of significant note is the fact that there were no checkpoints in any of the four land cover classifications that exceeded the 1.19 ft SVA accuracy criteria.

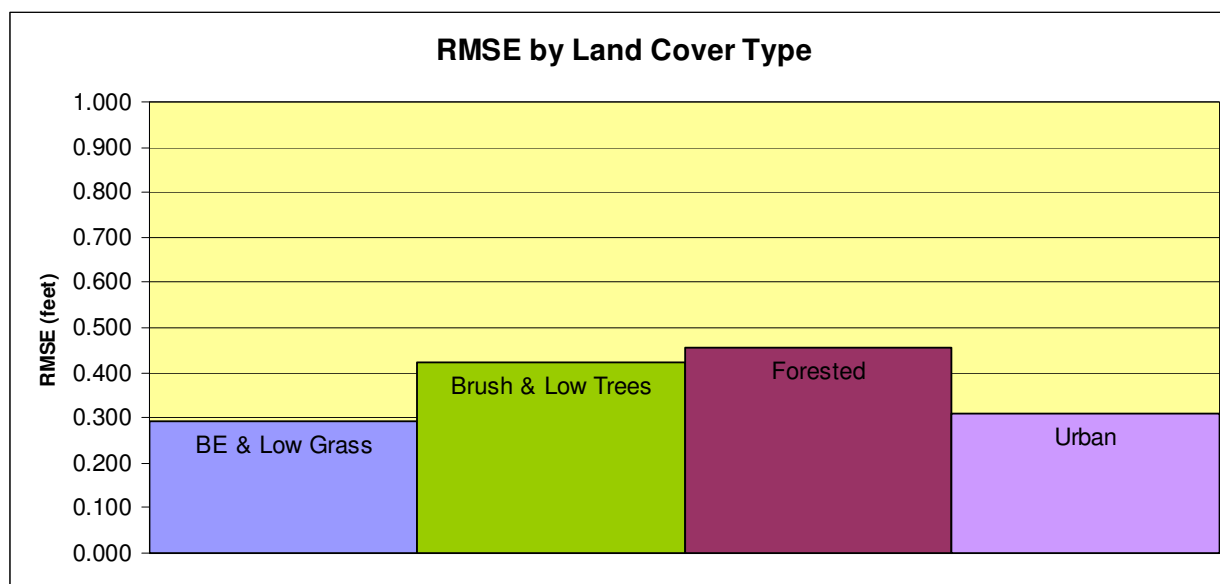
Figure 4 — RMSE_z statistics by Land Cover Category

The NSSDA and FEMA guidelines were both published before it was recognized that LiDAR errors do not always follow a normal error distribution. Future changes to these FGDC and FEMA documents are expected to follow the lead of the NDEP and ASPRS. Nevertheless, to comply with FEMA's current guidelines in Reference C, RMSE_z statistics were computed in all four land cover categories, individually and combined, as well as other statistics that FEMA recommends to help identify any unusual characteristics in the LiDAR data. These statistics are summarized in Figures 4 and 5 and Table 4 below, consistent with Section A.8.6.3 of Reference C.

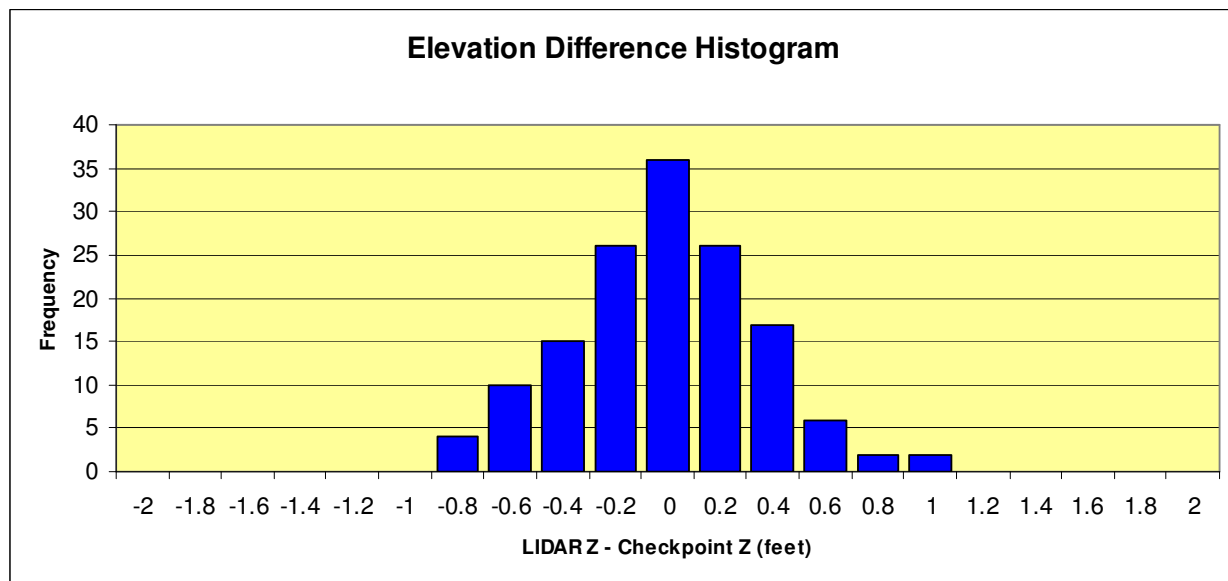
Figure 5 — Histogram of Elevation Discrepancies within 0.10 m Bands

Figure 5 illustrates a histogram of the associated elevation discrepancies between the QA/QC checkpoints and elevations interpolated from the LiDAR triangulated irregular network (TIN). The frequency shows the number of discrepancies within each band of elevation differences. Although the discrepancies vary between a low of -0.91 ft and a high of +0.99 ft, the histogram shows that slightly more of the discrepancies are skewed on the negative side of what would be a “bell curve,” with mean of zero, if the data were truly normally distributed. Typically the discrepancies tend to skew a bit more to the positive side, because discrepancies in vegetation are typically positive. However, the skew difference in this case is very minor, does not indicate any systematic error, and is of no concern.

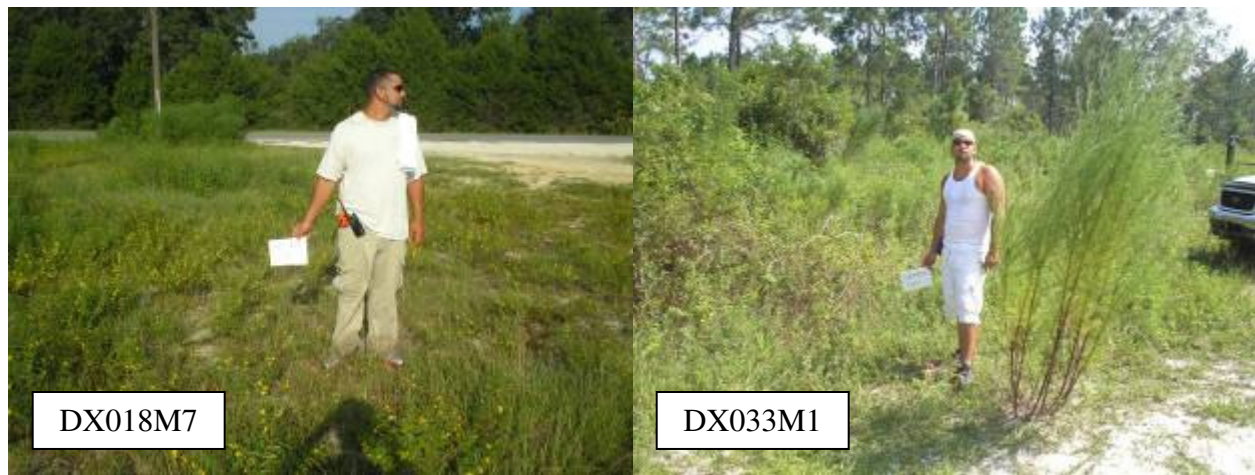
Figure 6 — Pictures showing locations for checkpoints DX018M7 and DX033M1

Figure 6 shows the digital pictures captured in the field for Category 1 checkpoints DX018M7 and DX033M1. These point location actually fit the criteria for Category 2 checkpoints, brush and low trees. These points were reclassified to Category 2 for the final vertical accuracy calculations.

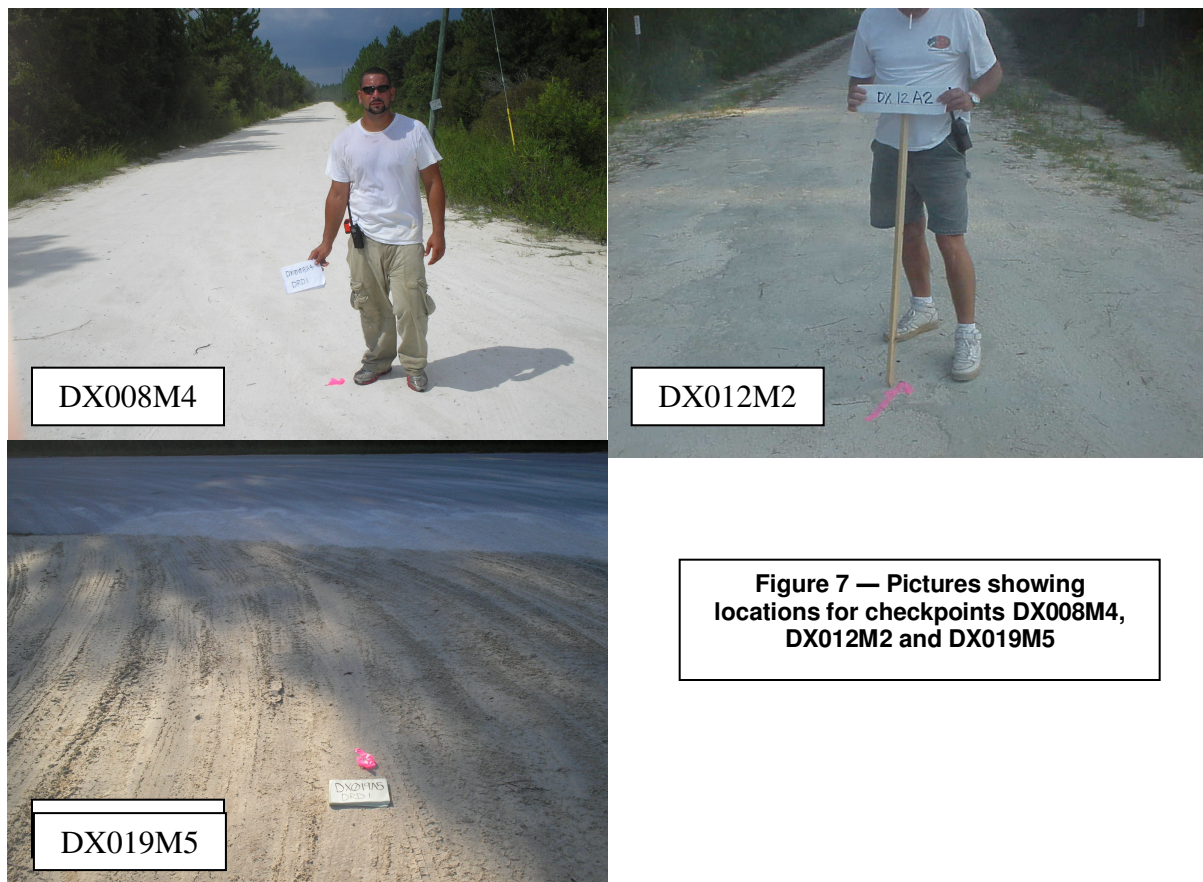
Figure 7 — Pictures showing locations for checkpoints DX008M4, DX012M2 and DX019M5

Figure 7 show the digital pictures captured in the field for Category 1 checkpoints DX008M4, DX012M2 and DX019M5. These points were changed to Category 2 checkpoints because they were located on dirt/sand roads that are subject to elevation fluctuations as a result of grading and or unusually high LiDAR intensity values.

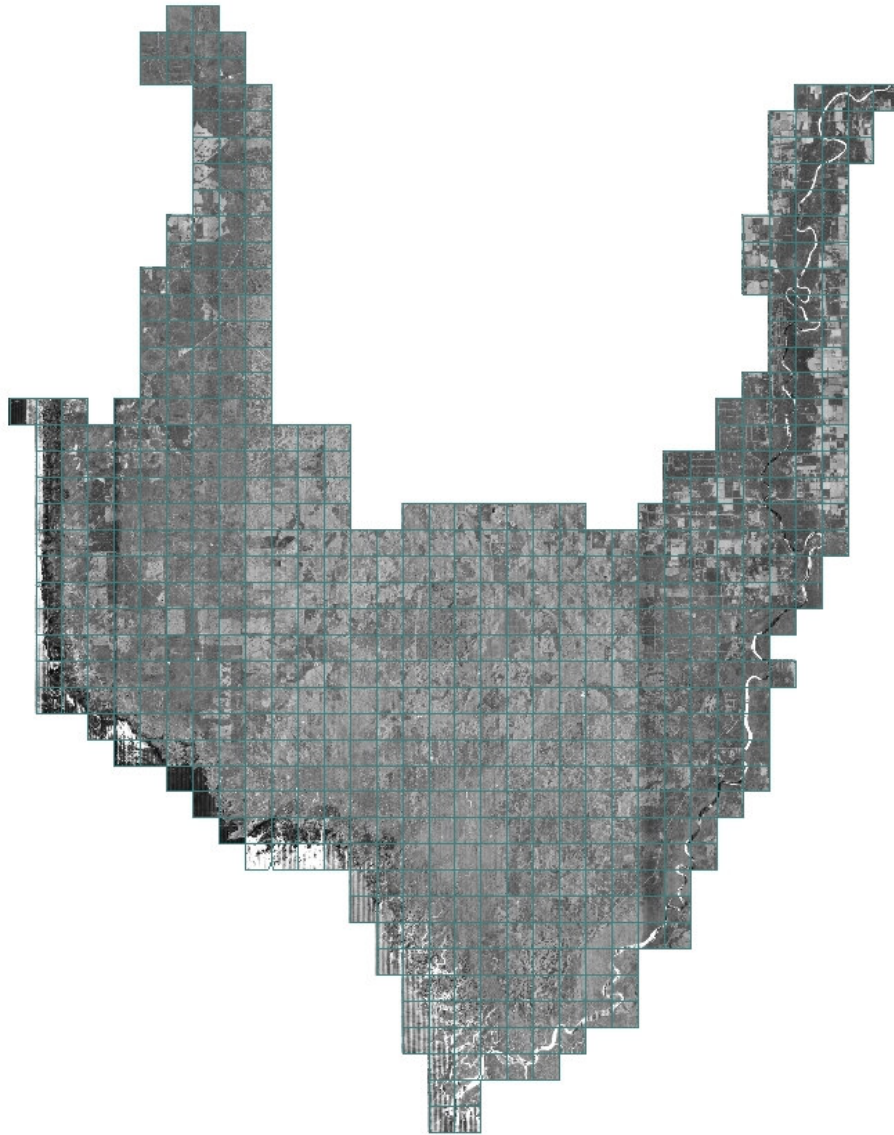
3. *Data Void/ Gap Checks*-The imported .LAS files were used to create LiDAR “orthos”. The LiDAR orthos were one of the tools used to verify data coverage and point density, to check for data voids or gaps, and to use as reference data during checks for data anomalies and artifacts. This product is not intended to be a project deliverable. The orthos were derived from the Full Point Cloud elevations and LiDAR pulse return intensity values. The intensity values were used as delivered with no normalization applied. Due to the point density of the Florida Baseline Specifications, the orthos were produced at a 1 foot pixel resolution for the entire area of interest (see Figure 1).

Figure 9 Screenshot of Dixie County LiDAR Orthos produced from Intensity Returns

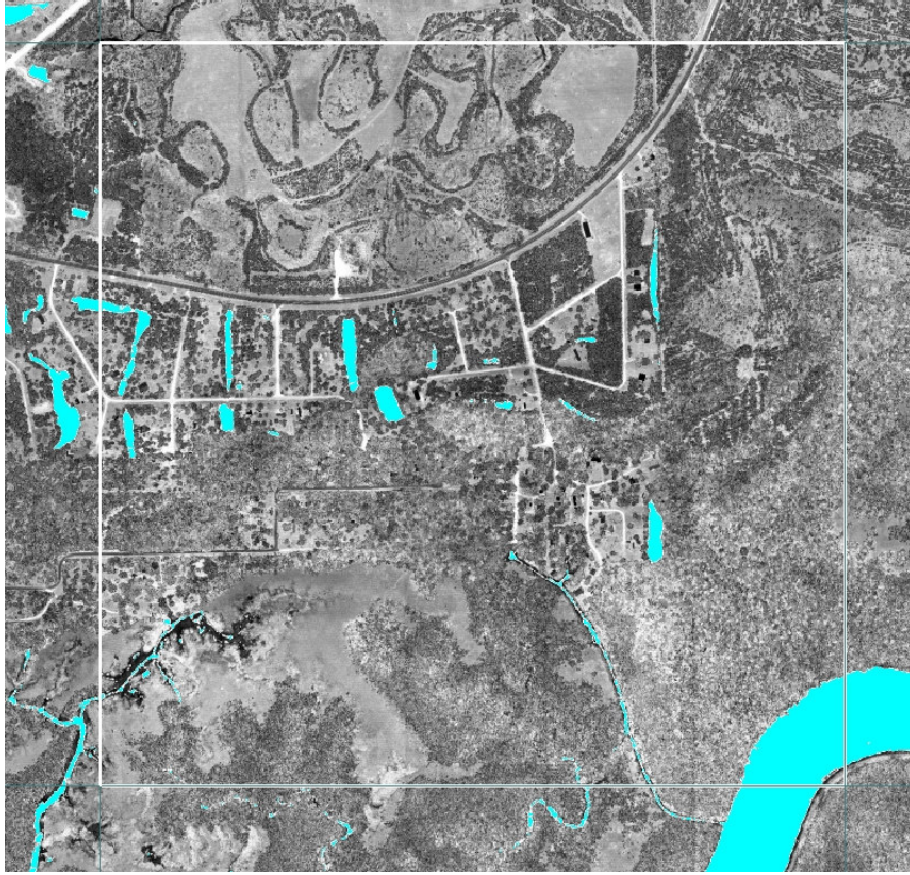
Voids (areas with no LiDAR returns in the LAS files) that are present in the majority of LiDAR projects include voids caused by bodies of water. These are considered to be acceptable voids (Figure 2).

Figure 10 Acceptable voids in data due to water bodies

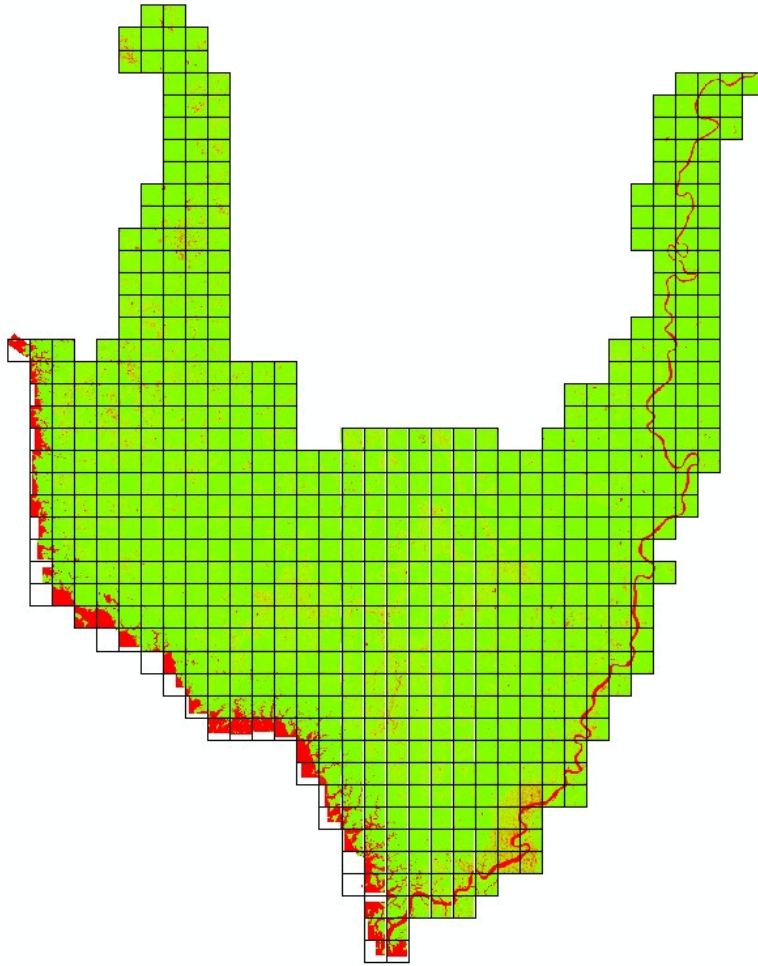
Model statistics were produced and characterized by density, scale, intensity, and elevation. (Figure 5) The low confidence area polygons were overlaid onto the density grids to ensure that all low confidence areas were properly identified with a polygon. As with the LiDAR orthos, this product was produced for Quality Assessment purposes only.

Figure 11 Density grid of Dixie County, created using a green to red color ramp. Green areas meet project specifications; red delineates areas not meeting minimum density requirements (primarily water and low-confidence areas)

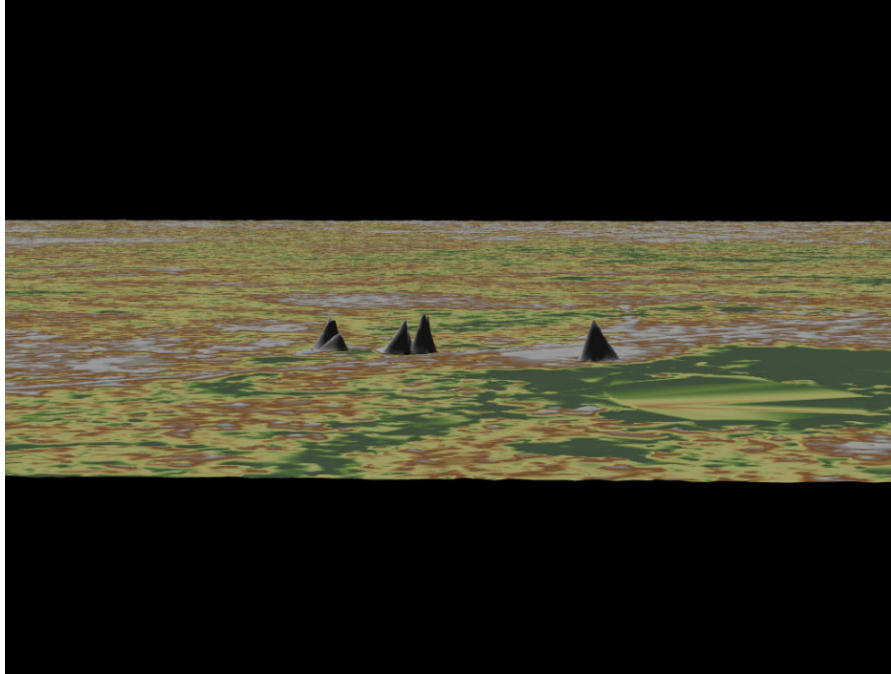
Figure 13 Tile 086706 – artifacts in ground points.

Points		
Tile	Issue	Code
LID 086706	Artifacts in ground points	Corrected
LID 077522	Lack of points on open road surface	Noted
LID 081310	Visible flight line seamlines	Noted
LID 080777	Box culverts removed	Noted

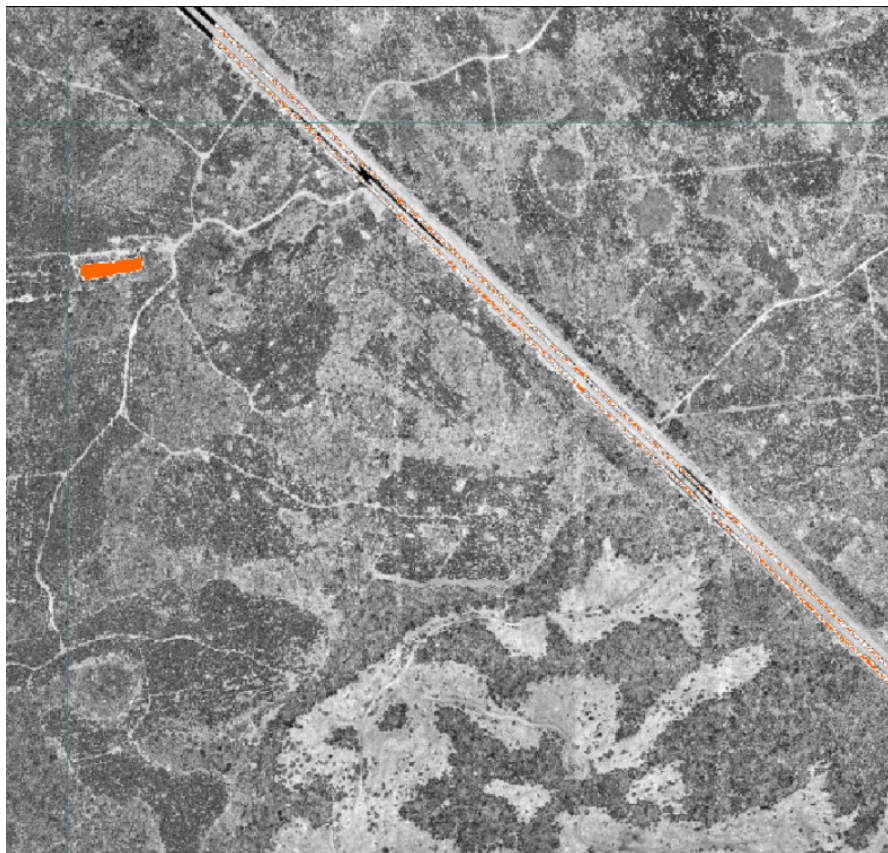
Figure 14 Tile 077522 – lack of points on highway surface.

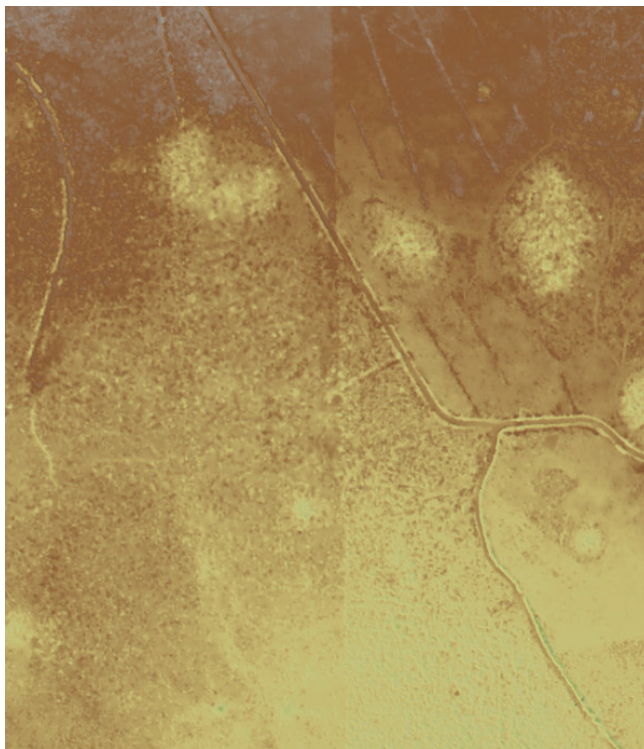
Figure 9 Tile 081310 – Visible seamline between flight lines.

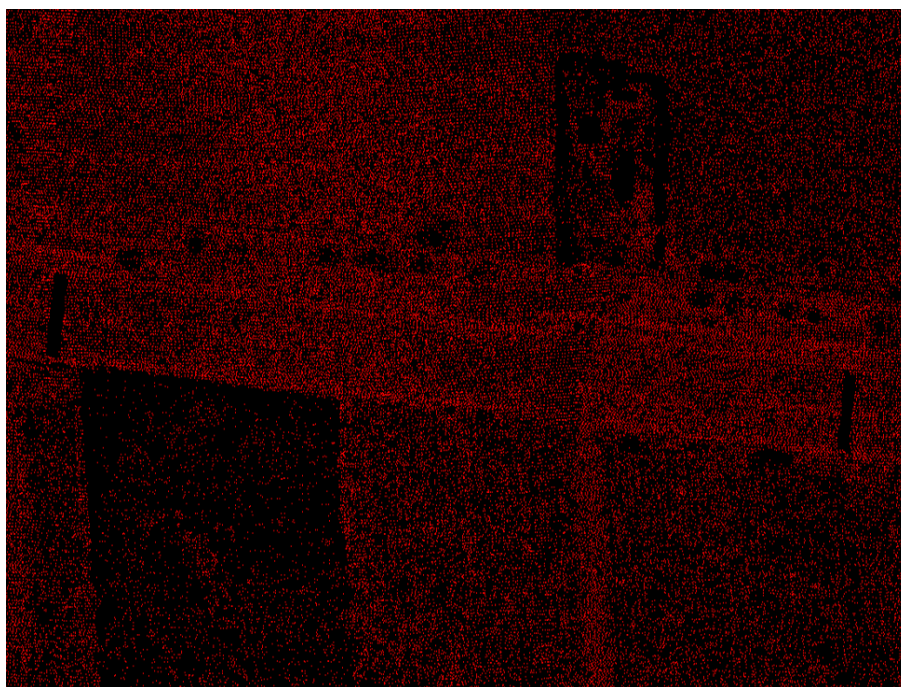
Figure 10 Tile 080777 – Culverts removed from bare earth classification

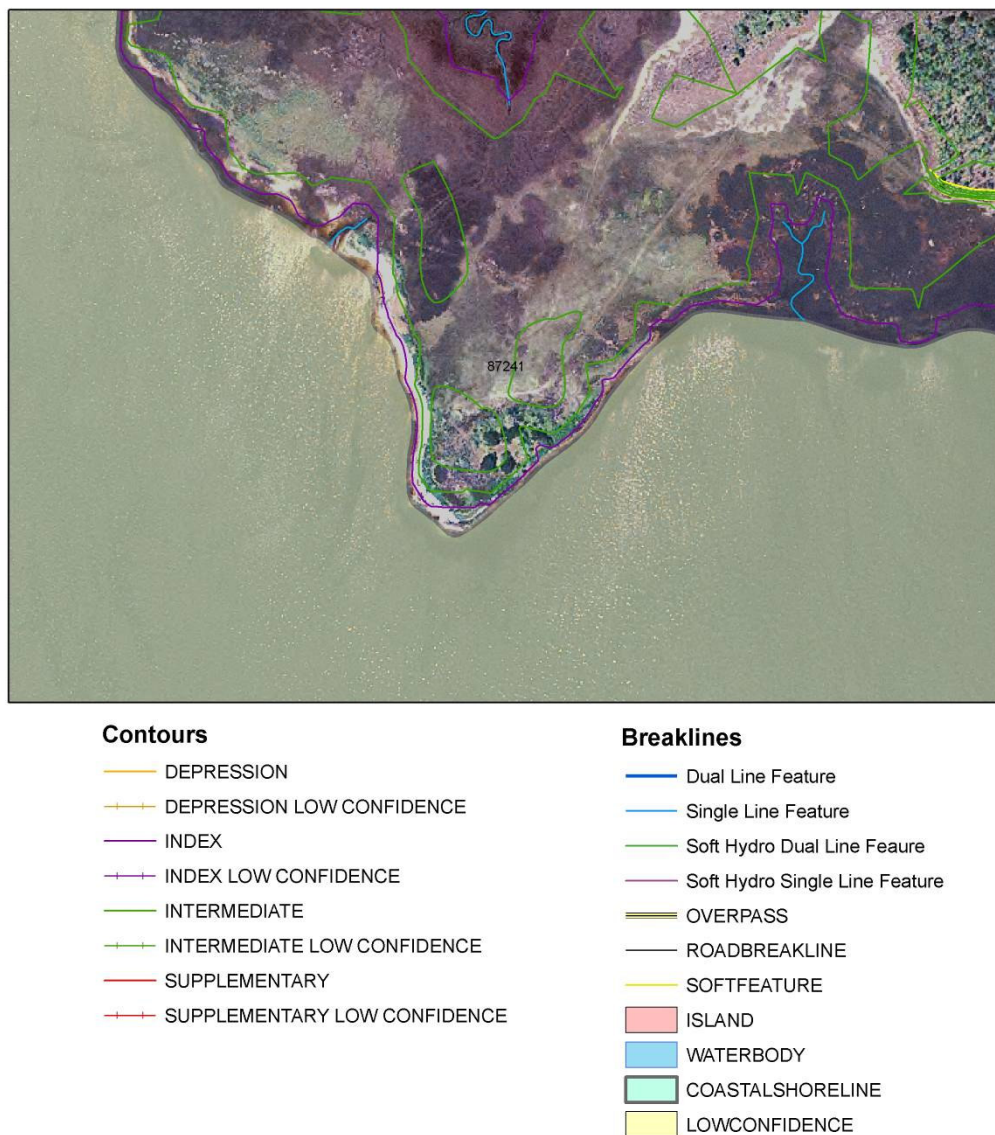
Coastal shorelines are correctly captured as two-dimensional polygon features, extracted from the LiDAR data and not from digital orthophotos, except for manmade features with varying heights such as seawalls which are captured as three-dimensional breaklines. Coastal breaklines merge seamlessly with linear hydrographic features. Shorelines continue beneath docks and piers. There is no “stair-stepping” of coastal shorelines. Figure 1 shows example coastal breaklines and contours.

Figure 1. Example coastal breaklines and contours from tile #87241

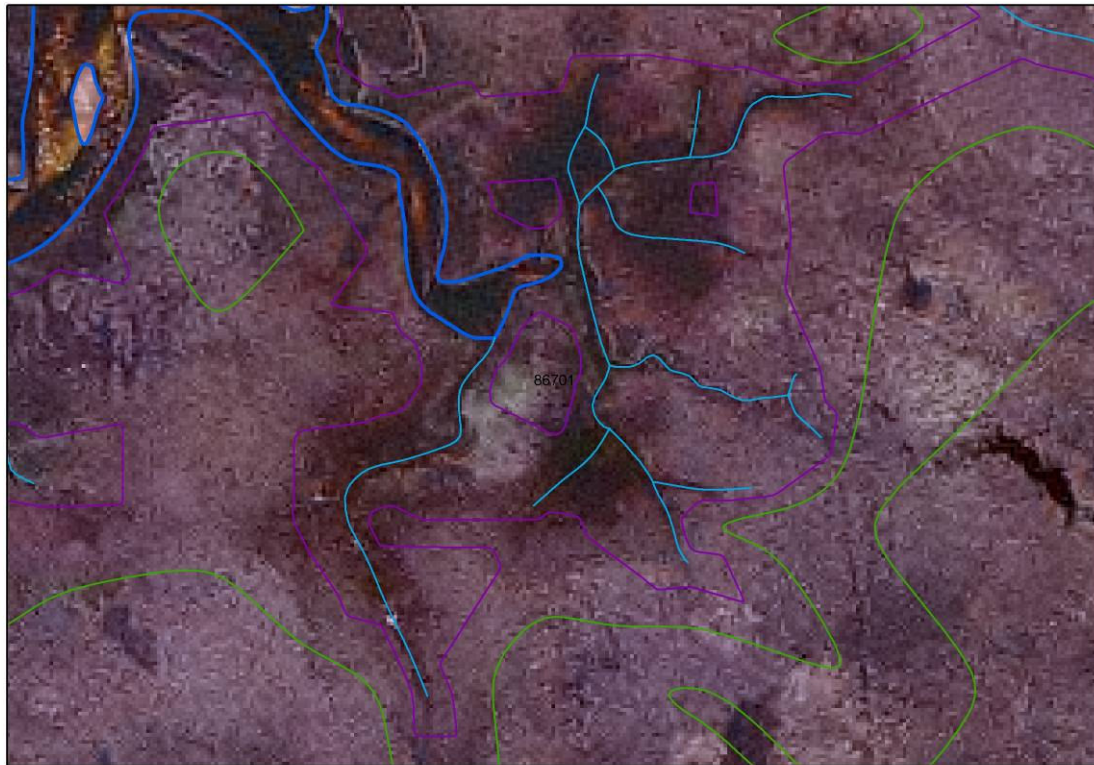
Linear hydrographic features are correctly captured as three-dimensional breaklines – single line features if the average width is 8 feet or less and dual line features if the average width is greater than 8 feet. Each vertex maintains vertical integrity. Figure 2 shows example breaklines and contours of linear hydrographic features.

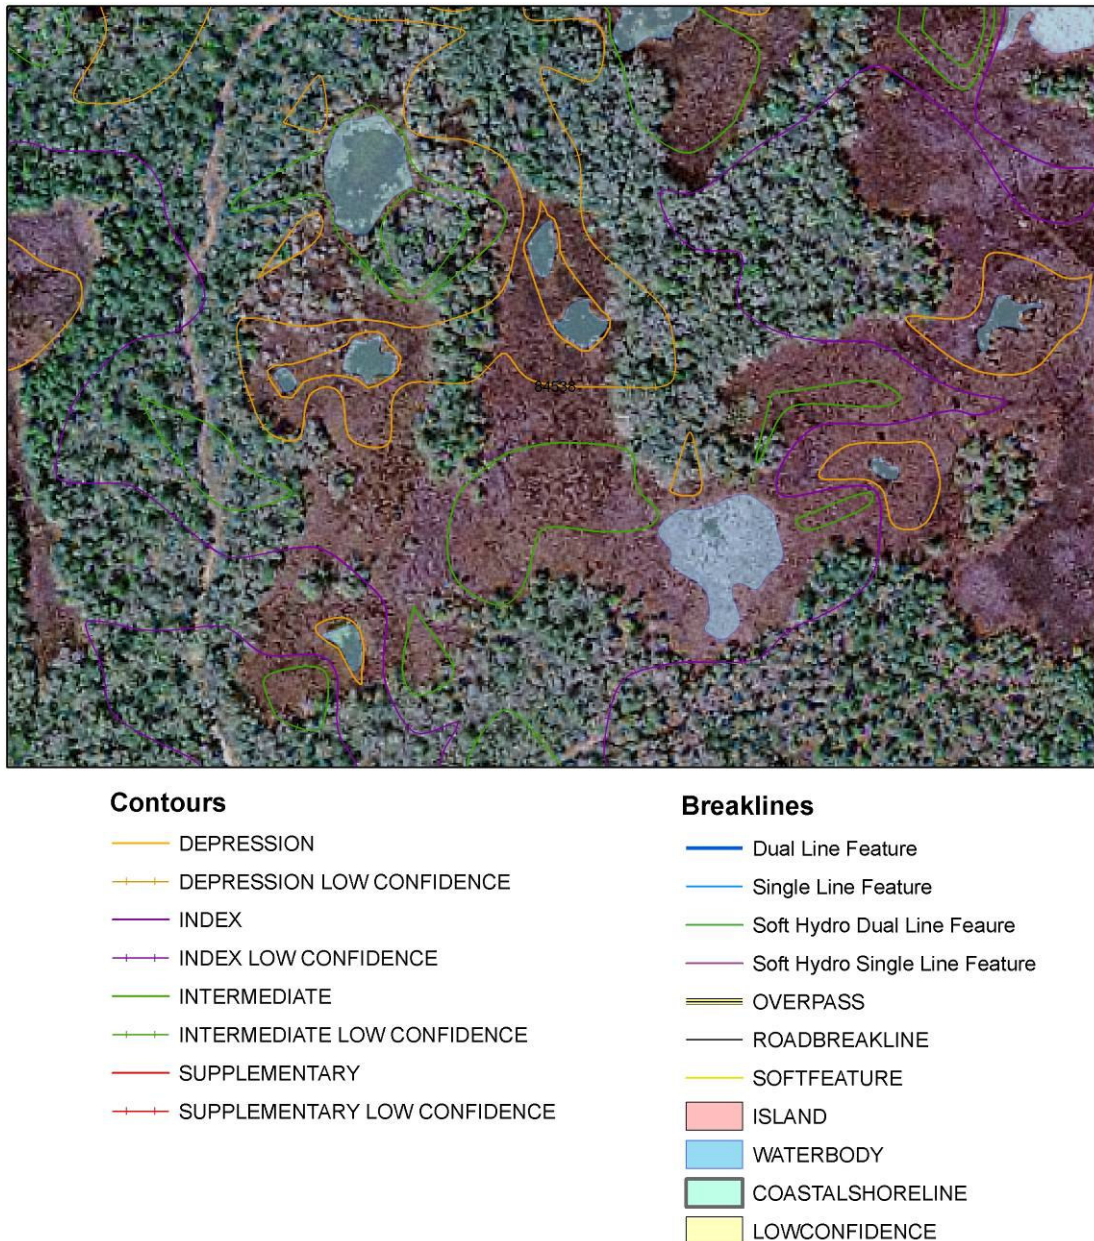
Closed water body features with an area of one-half acre or greater are correctly captured as two-dimensional closed polygons with a constant elevation that reflects the best estimate of the water elevation at the time of data capture. “Donuts” exist where there are islands within a closed water body feature. Figure 3 shows example breaklines and contours of closed water body features.

Figure 3. Example closed water body feature breaklines and contours from tile #84538

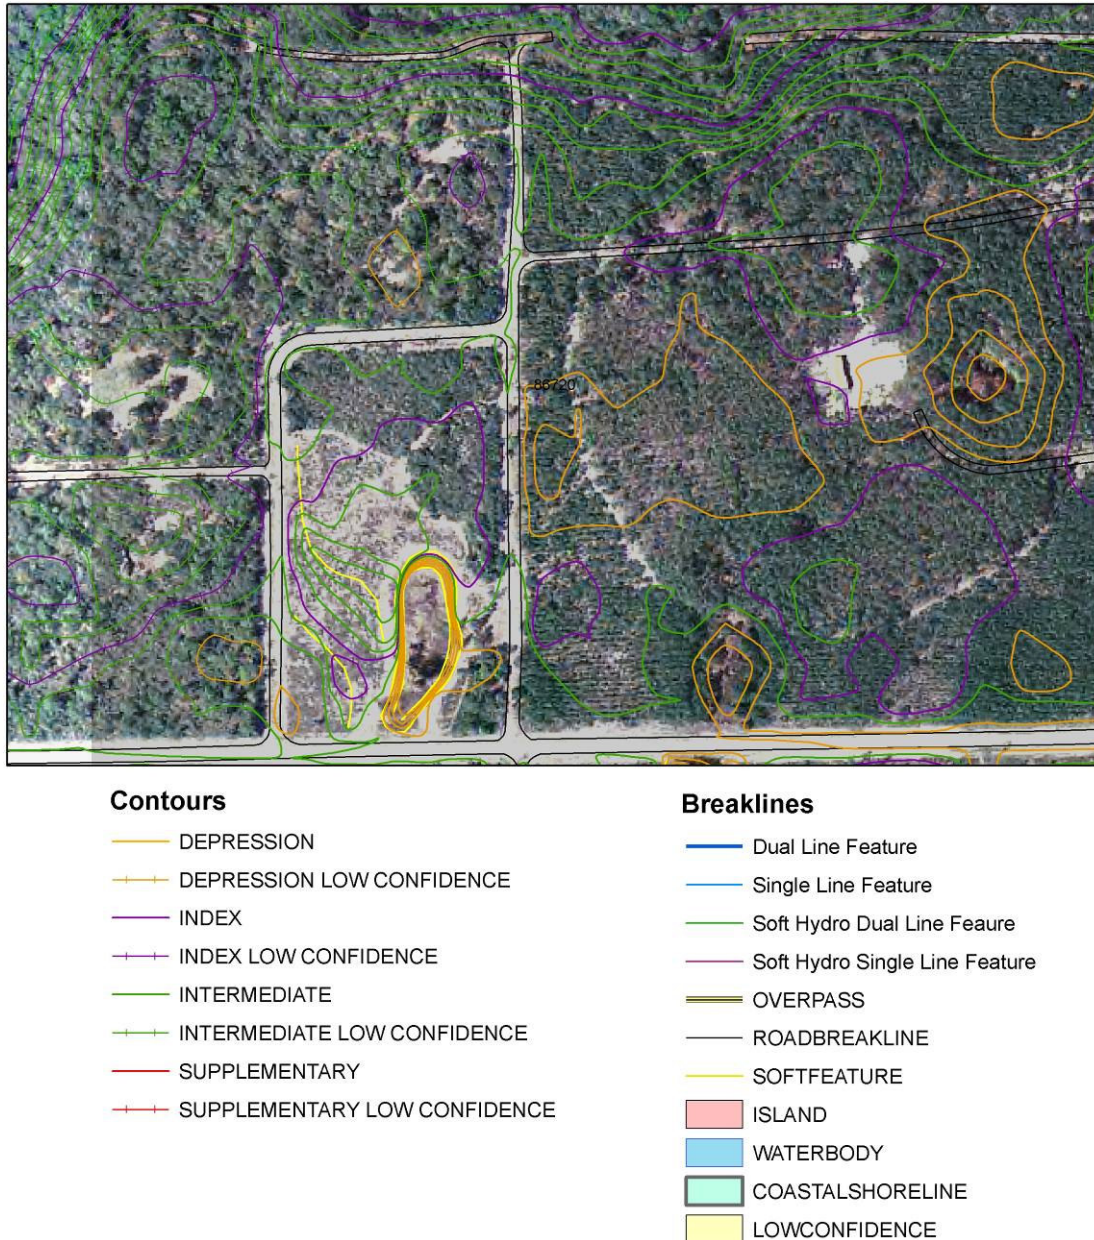
Road edge of pavement features are correctly captured as three-dimensional breaklines on both sides of paved roads. Box culverts are continued as edge of pavement unless a clear guardrail system is in place; in that case, culverts are captured as a bridge or overpass feature. Each vertex maintains vertical integrity. Figure 4 shows example breaklines and contours of road features.

Figure 4. Example road feature breaklines and contours from tiles #86720
